**Synergizing multi-criteria diagnosis for safeguarding cultural heritage and the restoration of vanished legacy: A historical exploration in science, technology, and archaeology**

**Abstract.** *The urgent need to preserve cultural heritage is starkly evident in contemporary society, particularly poignant in Morocco where its rich cultural legacy faces unprecedented threats. The rapid forces of urbanization and relentless economic development have converged, resulting in the alarming devaluation and irreversible degradation of a substantial portion of this invaluable heritage. Within this disconcerting backdrop, certain remarkable vestiges have managed to endure the ravages of time. One such exemplar is the Marinid Madrasa, an architectural marvel from the 4th century, nestled within the Chellah archaeological site in Rabat, Morocco. Beyond its physical grandeur, the Madrasa plays a pivotal role as a conduit between the past and the future, facilitating the transmission of cultural heritage to generations yet unborn. This paper embarks on a multidisciplinary journey, employing advanced techniques such as terrestrial photogrammetry, numerical modeling, and specialized archaeologic

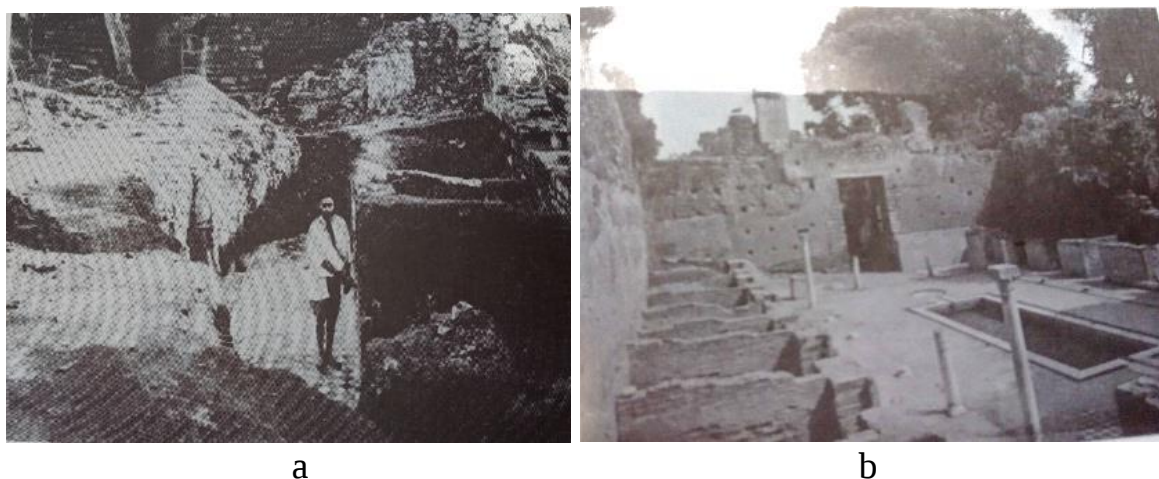
**Figure 2.** Documentation of excavations at the Medersa site in 1912 (a), Photographic documentation of the Medersa in 1920 (b) (source: Archive of the Ministry of Culture (Rabat, Morocco)).

The site encompasses remnants left by diverse civilizations, including the Phoenicians, Carthaginians, Romans, and Islamic peoples. Specifically, the focus was on the Marinid Madrasa (Figure 2), a remarkable architectural gem constructed by the Marinid dynasty, which held dominion over Morocco and the entire Maghreb region for nearly two centuries, spanning from the mid-13th century to the mid-15th century (Terrisse, 2011).

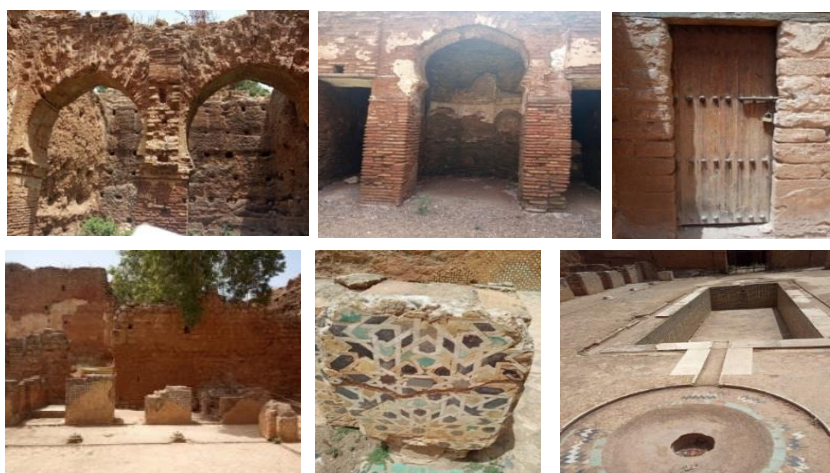
**Figure 3.** Example of building material and degradations of archaeological assets of Madrasa (Author's figure).

Many archaeological building monuments have suffered severe damage due to natural weathering processes, pollution influences, insufficient maintenance, utilization, and use of sensitive materials or inappropriate conservation (Theodoridou & Török, 2019). The current archaeological site (Marinid Madrasa) (Figure 3) has suffered these damages, and also the impact of groundwater due to rising aquifers. In (Table 1), the material type is presented as the entry, while the corresponding damage type/state is reported.

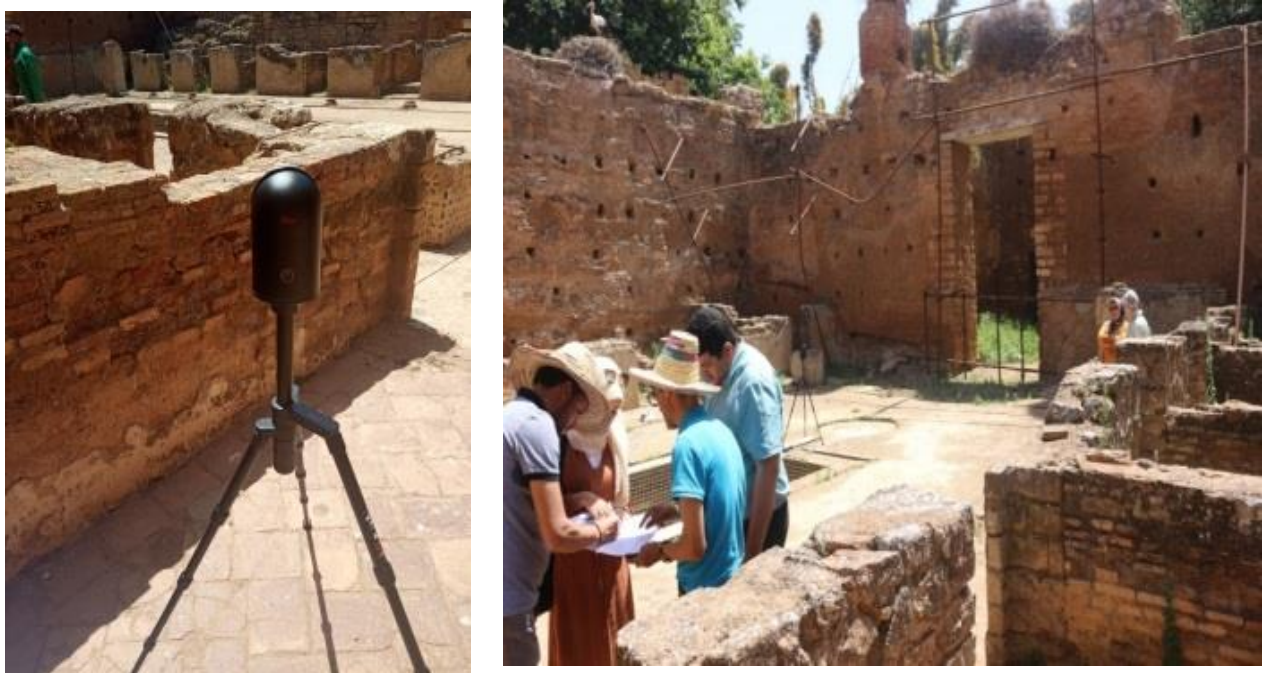
In this study, data of the Marinid Madrasa were obtained through TLS, using the Leica ScanStation 2 Laser Scanner (Figure 5), provided by the research team at the Laboratory of Applied Mechanics and Energy Recovery of Materials (LAMERN), Mohammed V University, Rabat. Multiple overlapping scans were acquired from selected positions to capture the surface details of the archaeological site. By achieving an average spatial resolution of 5-6 mm, the dense 3D point cloud acquired enables the generation of a meticulous digital model showcasing the enduring components found within the site, including the Mihrab and the North wall. This detailed representation significantly aids in the documentation of the archaeological assets present.

**Figure 5.** Laser data setting and capturing using Leica scan (Author's figure).

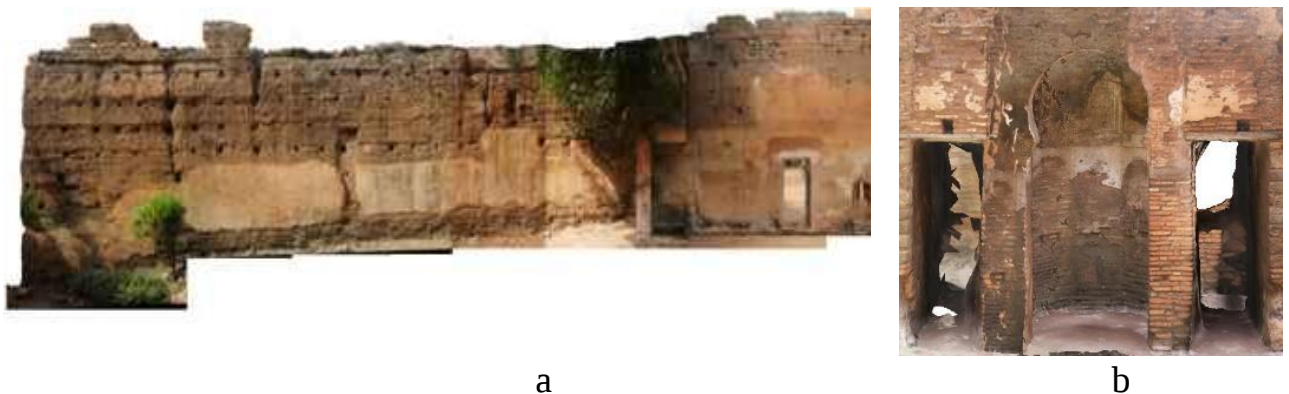
north wall of Madrasa site (Figure 6) however, these objects (Figure 7) are used as data for various conservatory analyses for damage and thematic mapping including not only qualitative information but also quantitative data. It is a very useful tool that allows saving the model in the form of virtual copy (Tsilimantou et al., 2020). The acquired models represent the sole available information regarding this archaeological site, serving as an invaluable resource for future research endeavors.

**Figure 7.** Orthoimages of (a) the North wall (b) the Mihrab (Author's figure).

The 2D plans corresponding to the Mihrab and the North wall are extracted from the digital models provided by the cloud points using AutoCAD. Each element of the drawing has been classified according to architectural detail, distribution of building material and type of degradation.

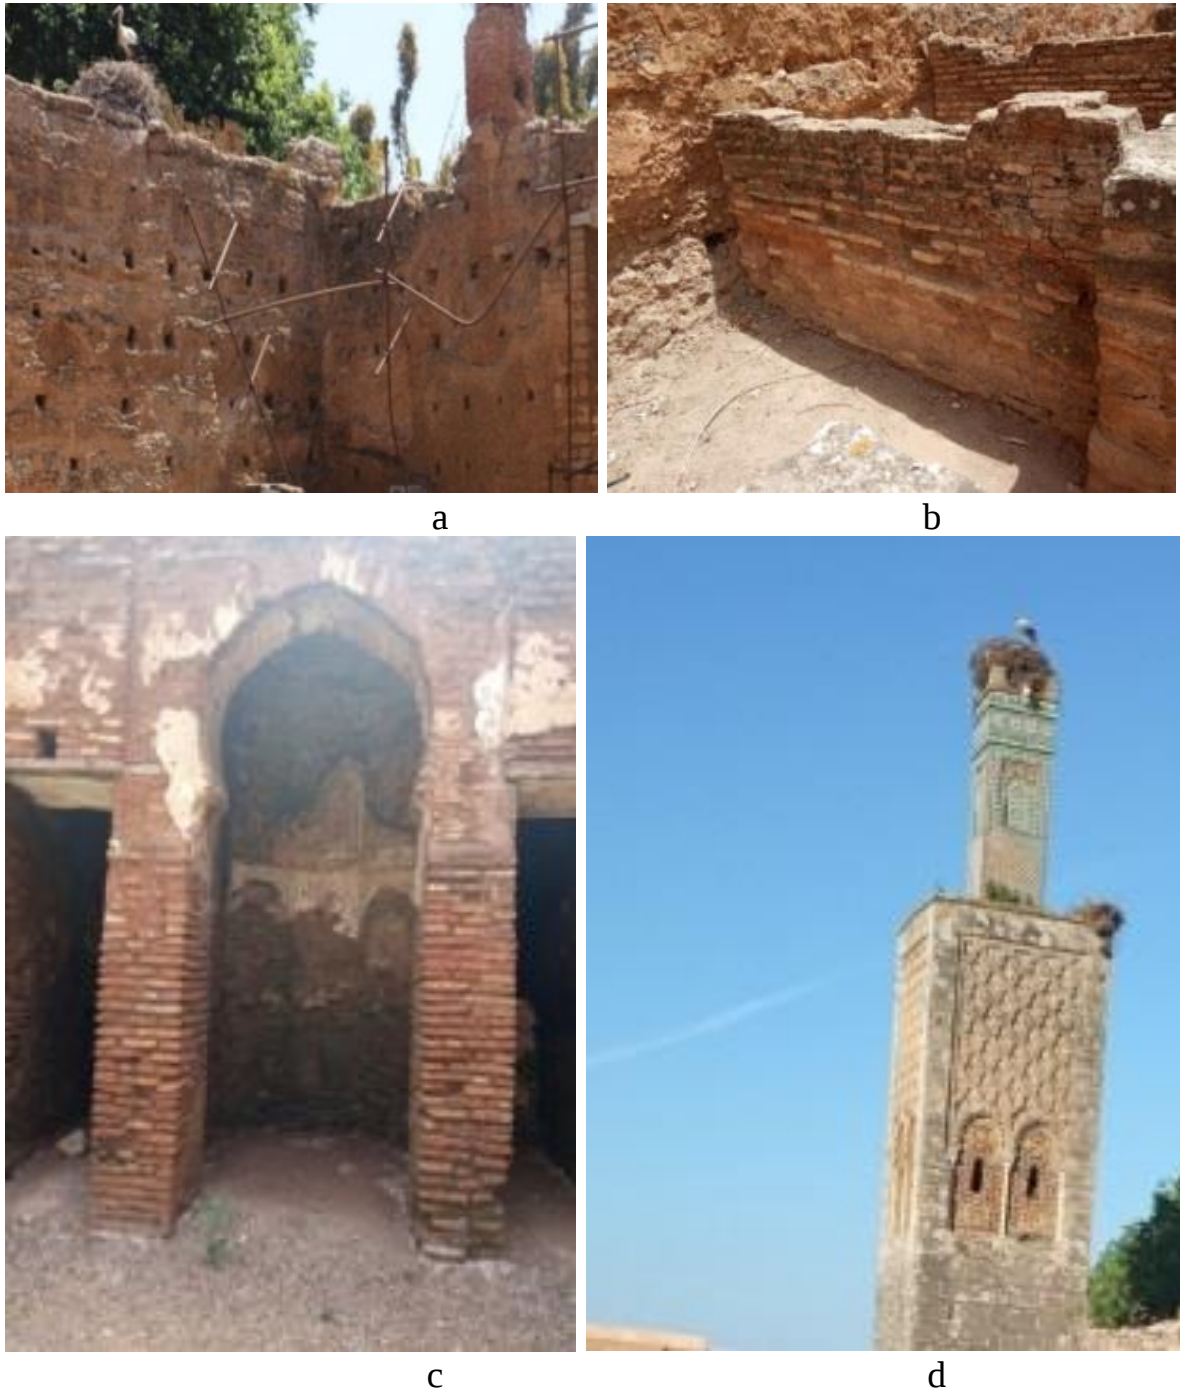
**Figure 8.** Different archaeological parts of Marinid Madrasa (Author's figure): North wall (a), Remains of chambers (b), The Mihrab (c), The Minaret (d).

The Madrasa is located in the northeastern part of the Chellah archaeological site and comprises a prayer room, an open-air courtyard, a Minaret, and several cells for students. The damaged remains consist of a central courtyard with a beautiful basin at its center, surrounded by a scroll adorned with small columns and marble columns. On the East and West sides, there are a series of rooms. Towards the south, there is a small rectangular prayer hall with two parallel naves along the Qibla wall. In the center, there

is a pentagonal Mihrab decorated with stuccoes featuring various motifs. On the opposite side, in the northern area, stands a slender Minaret (Fig. 8.d) that still retains its architectural characteristics from that period. The Minaret is square-shaped and consists of two floors. The first floor is constructed with adobe bricks, embellished with geometric motifs formed by intersecting stone lozenges. The smaller second floor is covered on all four sides with ceramic tiles of different colors.

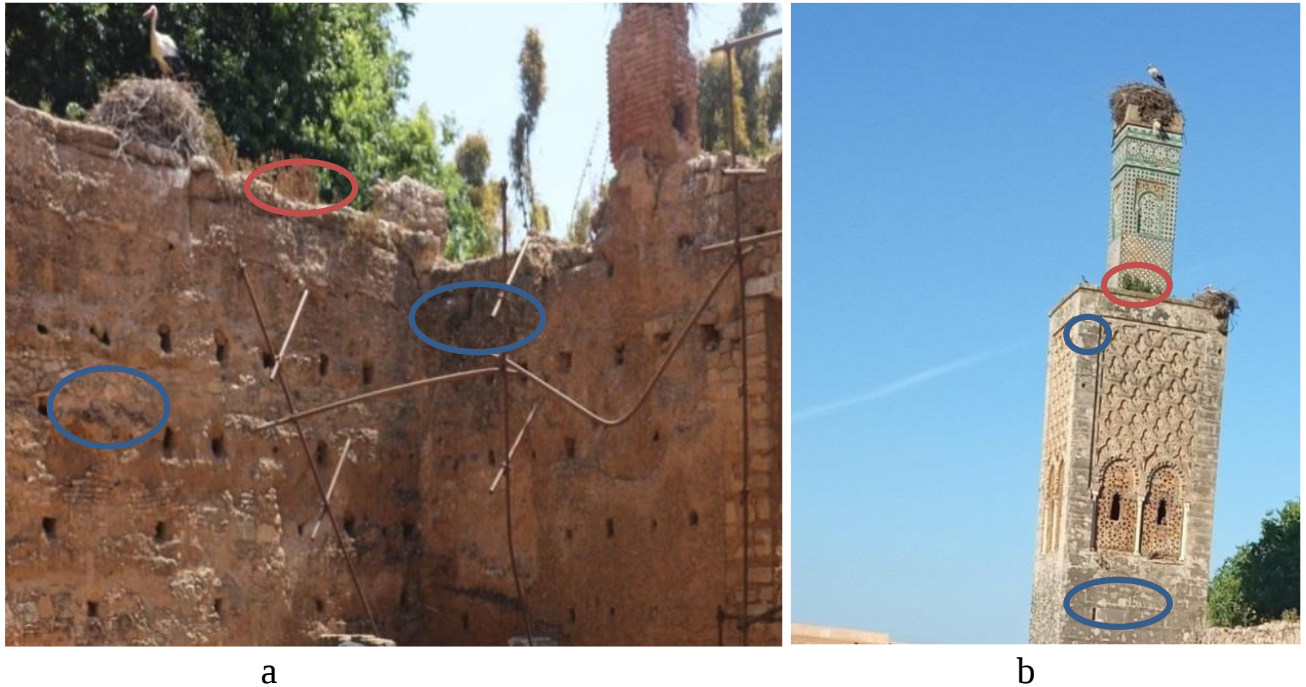
The development of lichens (Marked with blue circle) on the wall causes physico-chemical damage because of their metabolic activity (production of oxalic acids) and an aesthetic inconvenience Figure 12-a. The development of lichens causes physico-chemical alterations and aesthetic inconvenience (Minaret of Chellah) Figure 12-b.

**Figure 12.** (a) North wall and (b) Minaret of Madrasa with the evolution of lichens (Author's figure).

Also, the roots of plants (Marked with the red circle) in addition to the former exert mechanical thrusts causing fractures. The excrements of birds (oxpeckers and storks) also cause chemical degradation (Chellah lichen). The issues encountered on this site are related to humidity, the presence of water, atmospheric pollution, vegetation growth, lack of sanitation inside and outside the site, the primary construction technique and the previous rehabilitation and conservation processes.
